# STONHARD *Solutions*

## *The Right Floor and A Systematic Installation for Ontario's Millhaven Institution*

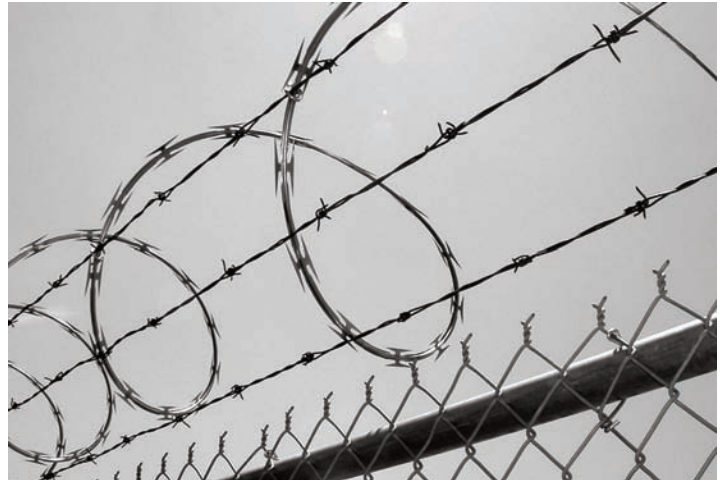
*After complete devastation of the institution's floors, Stonhard was able to provide a durable, long-lasting flooring solution.*

Stonhard's Stonclad GS, a seamless epoxy mortar system noted for its durability, wear and impact resistance, was recommended for the cells and corridors. Stonshield HRI, also a durable epoxy system, was suggested for the day rooms because it offers a textured, slip resistant surface along with a decorative finish.

Stonclad is installed over the substrate at ¼ inch thickness with coves applied up the walls at 4-inch radii. The coves make cleaning simpler and eliminate space for dirt and bacteria to become trapped.
