# STONHARD *Solutions*

## *Stonhard Resolves Leaky Floor Problems at Hyatt Regency Chicago*

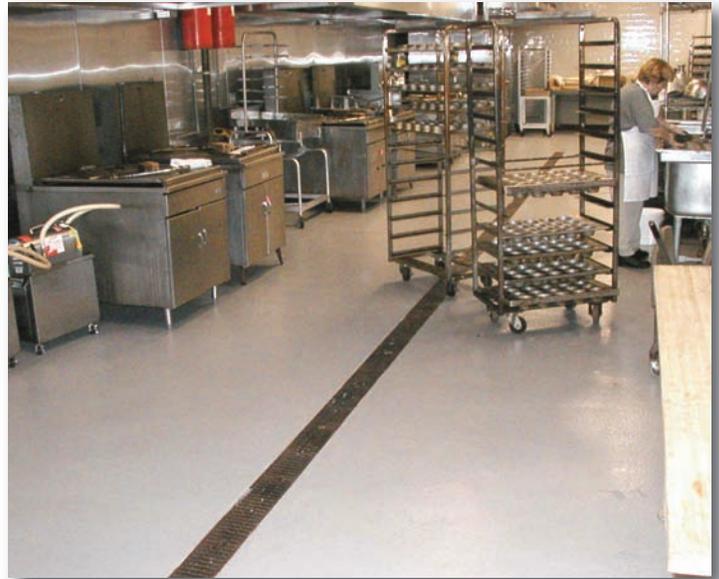
*Stonhard replaced Hyatt's problematic tile floors with Stonclad UT, resulting in a seamless, easy to maintain floor.*

shock, exhibited the worst cracking. The tile, along with the grout bed, was removed and replaced with Stonset TG6, a quick-setting grout, and Stonclad UT, a textured mortar system. This solution was put into service and effectively solved the problem. Due to this success, Stonhard

The project was scheduled during the month of January – the least busy month of the year for the Hyatt Regency Chicago. Equipment was removed by Hyatt Regency's engineering staff and all meals scheduled for preparation in the main kitchen were distributed among the other six kitchens. Stonhard's crew removed all existing tile and grout. A sub-contracted concrete company cut out and reset the drains and then poured fresh concrete to rebuild the height and pitch of the original floor. After a seven-day cure, the concrete was blasted and 7,200 square feet of Stonhard's Stonclad UT was installed. From demolition to completed floor installation, the project took 23 days.
